NBSIR 83-2677

Analysis of Electrical Fire Investigations in Ten Cities

March 1983

Alan Gomberg and John R. Hall, Jr.

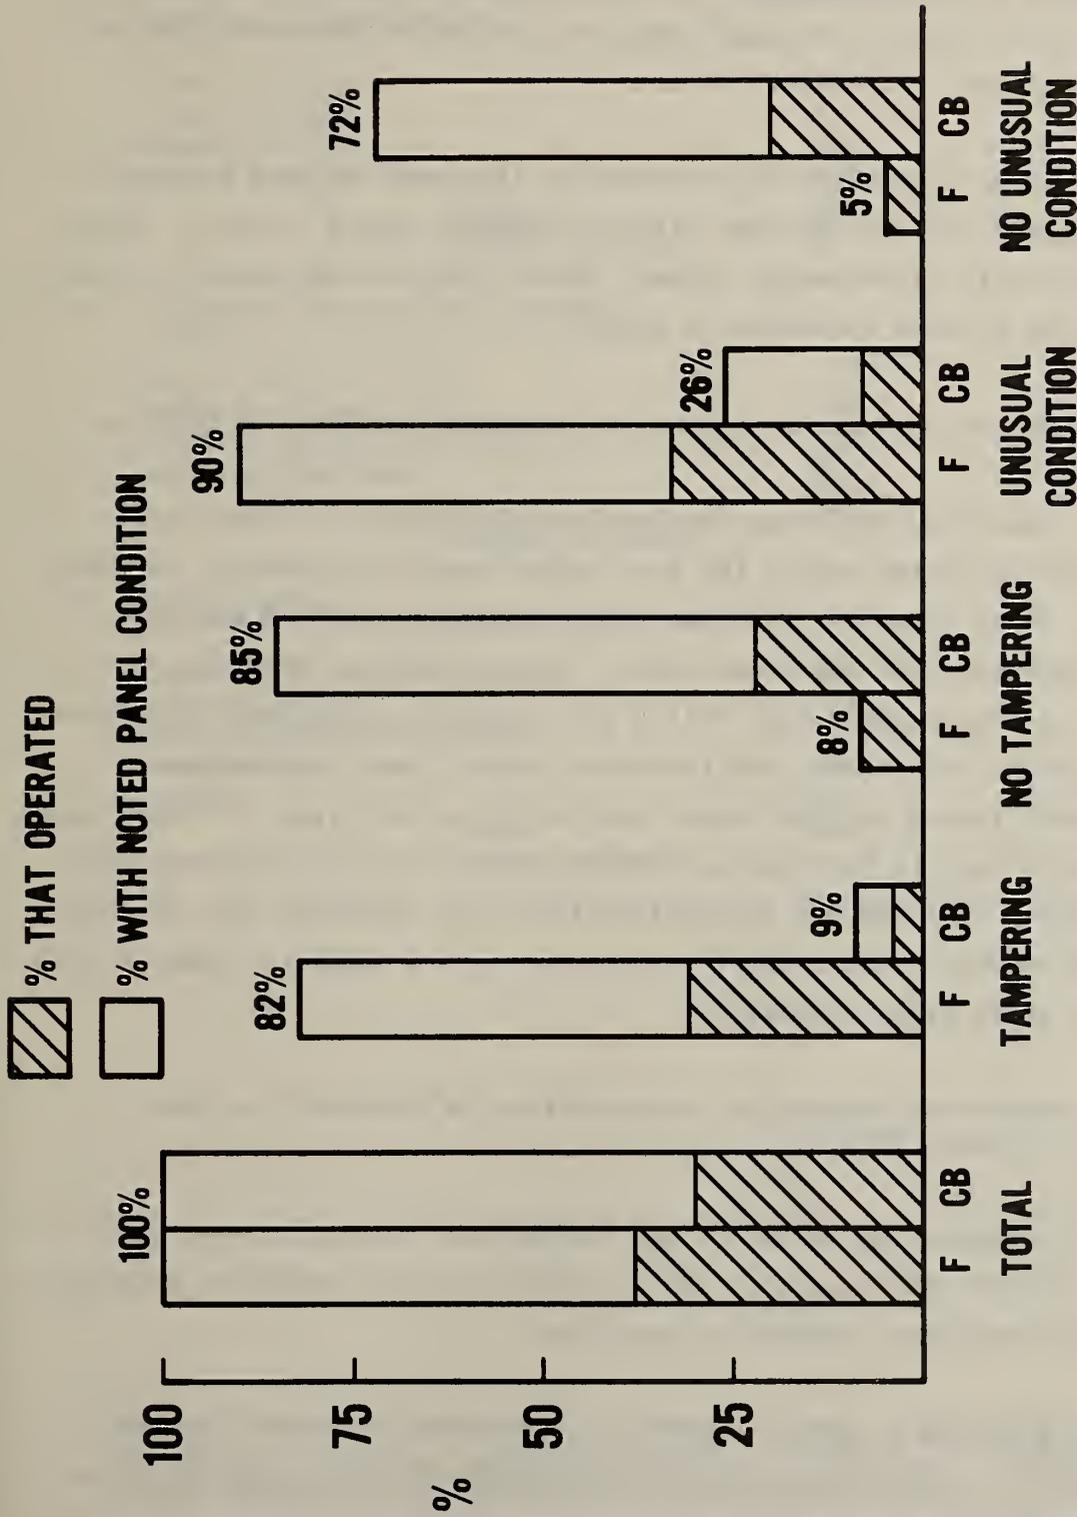
Figure 1. Performance of Overcurrent Protection Devices, by Type of Device and with Reference to the Presence or Absence of Tampering and Unusual Panel Conditions

Figure 1 shows the contrast in tampering and unusual panel conditions between fuses and circuit breakers and shows the impact on the performance of the devices. Both fuses and circuit breakers managed to interrupt current in some cases when they were tampered with or hampered by unusual conditions. Fuses, however, always interrupted the current in those few cases when neither of these conditions were present, but circuit breakers did not. This unusual finding regarding circuit breakers stimulated several additional analyses aimed at identifying the reasons for non-performance.

In summary, the pattern of performance for both major devices - circuit breakers and Edison-base fuses - shows them failing to interrupt the current in well over half the cases. For the fuses, the story is essentially one of widespread tampering, but for the circuit breakers a promising explanation has proved elusive in this initial analysis.

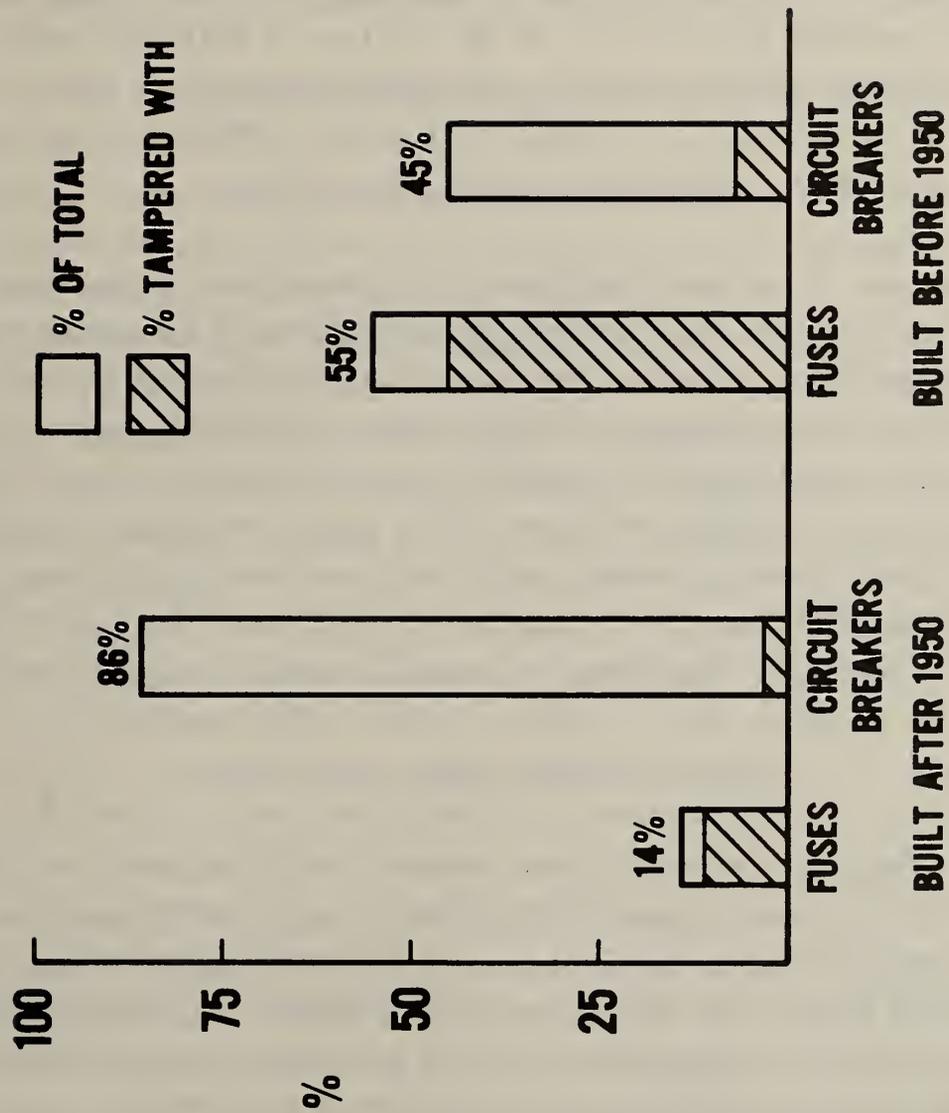
Figure 2. Tampering by Year Built and Type of Overcurrent Protection Device

Tampering with the overcurrent protection device is correlated with building age primarily because use of fuses is correlated with building age, as figure 2 demonstrates. Of the 29 fires in buildings built in 1950 or after and having Edison-base fuses or circuit breakers, 3 of the 4 buildings with fuses were tampered with, while only 1 of the 25 buildings with circuit breakers were tampered with. This gives an overall tampering rate of at least 14% (4 out of 29). (The qualification "at least" is needed because in two circuit breaker cases the report did not indicate whether tampering had occurred.) Of the 60 fires in buildings built before 1950 and having Edison-base fuses or circuit breakers, 27 of the 33 with fuses were tampered with while only 4 of the 27 with circuit breakers were tampered with, producing an

overall tampering rate of at least 52% (31 out of 60). (Again, the result is qualified because in 4 fuse cases and 1 circuit breaker case it was not determined whether tampering had occurred.)
